NAVORD REPORT 2830

INVESTIGATION OF PREMATURES EXPERIENCED
IN MAJOR CALIBER PROJECTILES

27 JULY 1953

U. S. NAVAL ORDNANCE LABORATORY
WHITE OAK, MARYLAND

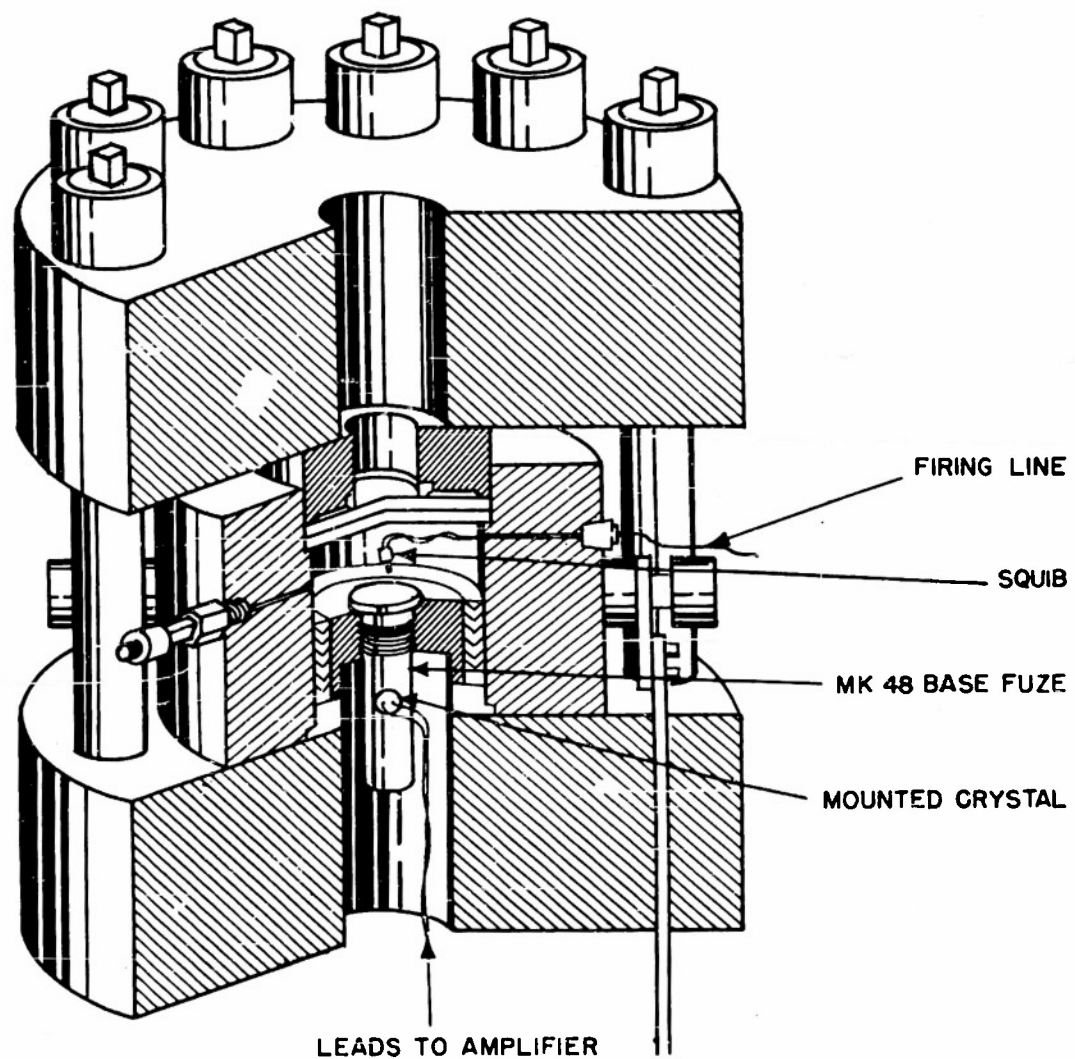
FIG. 2 DYNAMIC PRESSURE PULSE GENERATOR
(THUNDERMUG)

10. The Dynamic Pressure Pulse Generator (Thundermug), Figure 2, is a laboratory apparatus which subjects components to be tested to pressure-time characteristics similar to pressure pulses created in firing a gun. It consists of a cylindrical firing chamber closed at one end with a gasketed adapter in which a fuze may be mounted, and at the other by a heavy diaphragm. A black powder charge is fired in the chamber electrically, through leads in the cylinder wall. The pulse rise rate is controlled by the grain size of the black powder, the peak pressure jointly by the size of the charge and the thickness of the diaphragm which ruptures, and the pressure decay rate by the size of the aperture through which gases are expelled

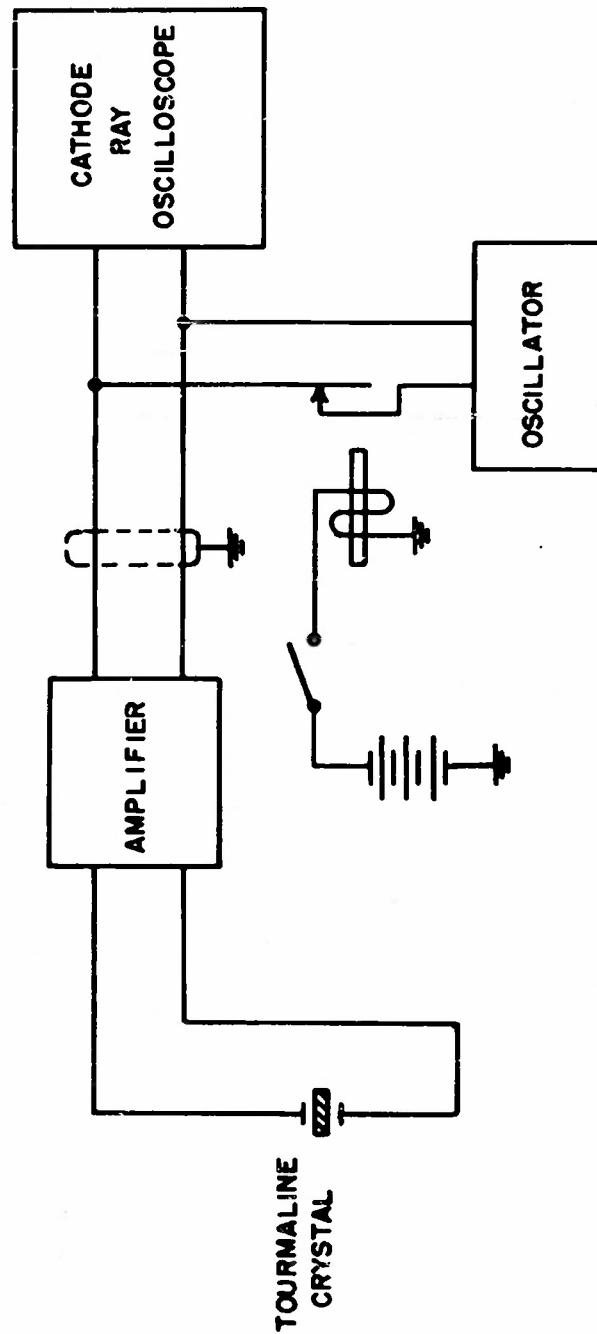
FIG. 5 INSTRUMENTATION FOR RECORDING GAS LEAKAGE

16. A Keithley Phantom Repeater was used as an impedance matching device between the crystal and the CRO (Figure 5). The time constant of the input circuit was increased by shunting the repeater with a .005 ~~micro~~ farad capacitor.
